REPORT NO. NADC-78220-60

**THE DEVELOPMENT OF AMLGUARD, A CLEAR, WATER  
DISPLACING, CORROSION PREVENTIVE COMPOUND**

Gabriel J. Pilla  
Aircraft and Crew Systems Technology Directorate  
NAVAL AIR DEVELOPMENT CENTER  
Warminster, Pennsylvania 18974

11 May 1979

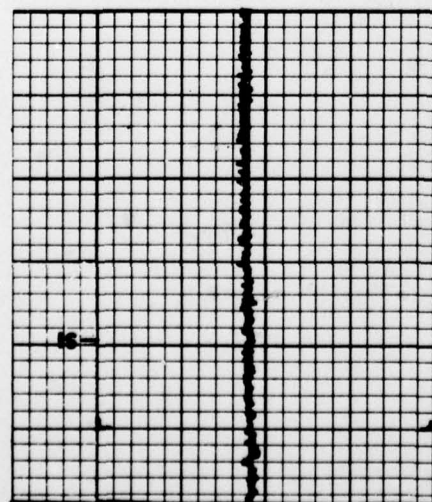
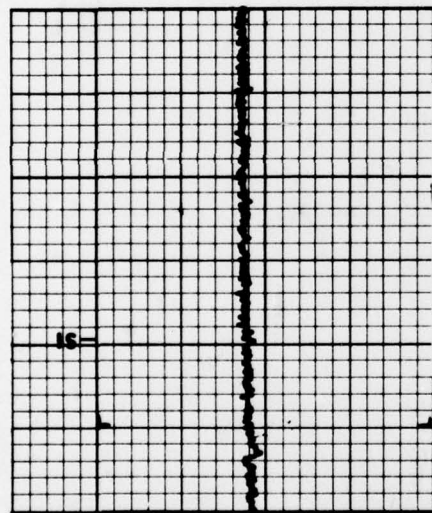
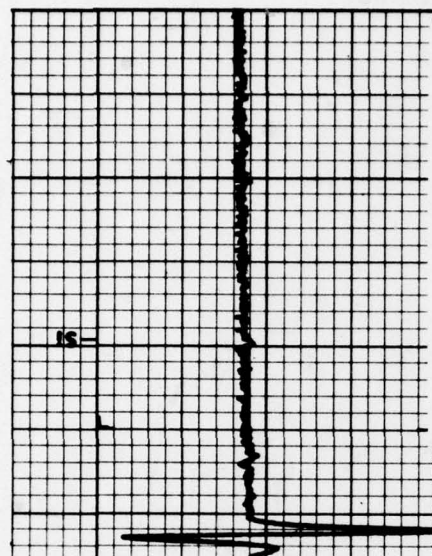
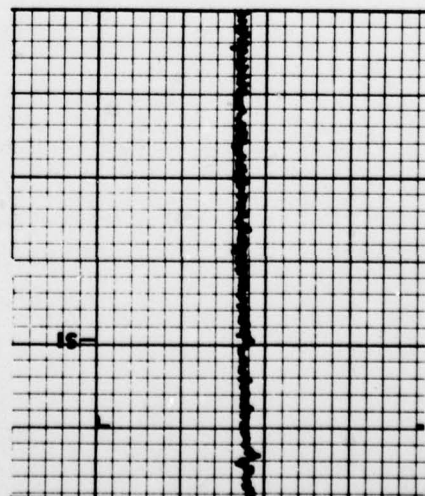
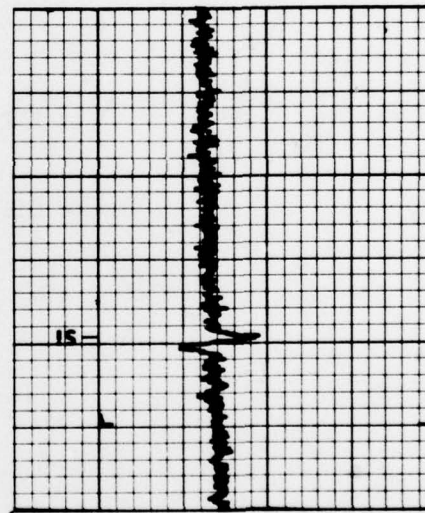
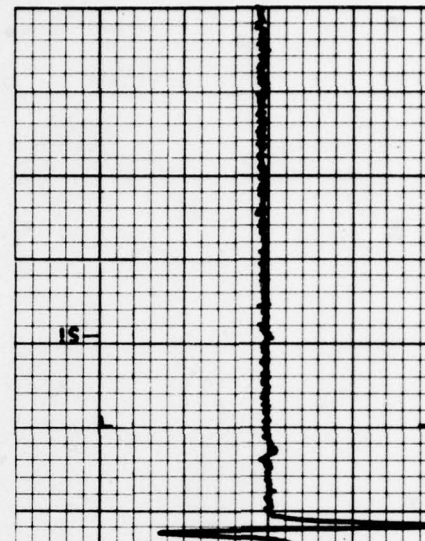
G-2

SPECTROGRAMS OF 7075 ALCLAD ALUMINUM AFTER AMLGUARD APPLICATION  
AND SOLVENT WIPE REMOVAL TREATMENT

Test conditions performed were identical to the first set of specimens sent to Lehigh University for analysis, except these specimens were solvent wiped twice to remove AMLGUARD. Results confirm the findings of the initial test work, that is, proper solvent cleaning will thoroughly remove AMLGUARD from metallic surfaces, including methyl ethyl ketone which initially showed trace amounts of silicon remaining on the metal surface with one solvent wipe. During this second surface analysis it was found that MIL-C-43616 solvent emulsion cleaner did not adequately remove AMLGUARD for subsequent refinishing and should not be used for this purpose, see Naval Air Development Center, Warminster message R122301Z May 78 (Appendix J).

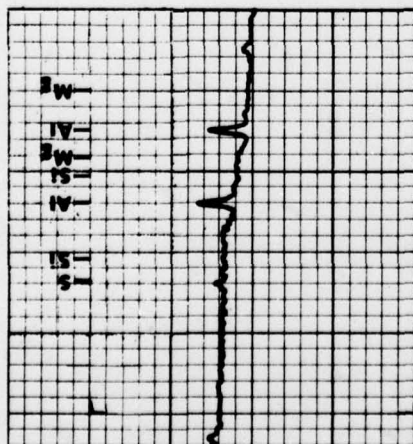
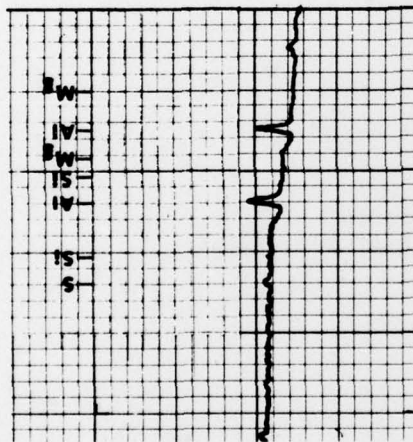
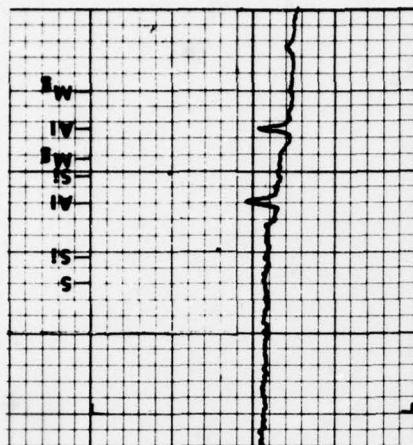
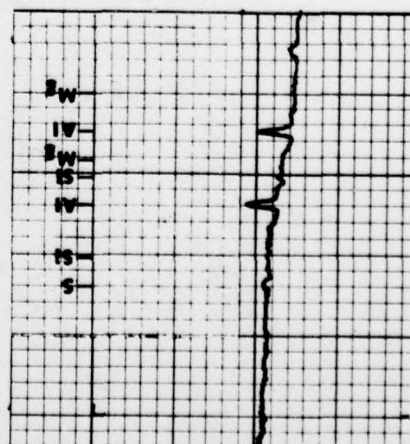
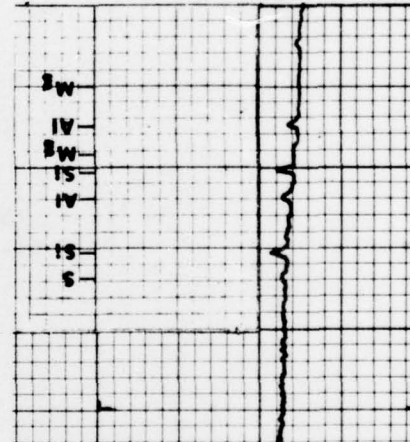
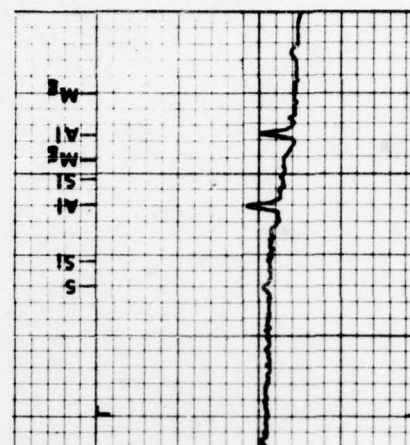
H-2

SPECTROGRAMS OF 7075 ALCLAD ALUMINUM AFTER AMLGUARD APPLICATION  
AND SOLVENT WIPE REMOVAL TREATMENT

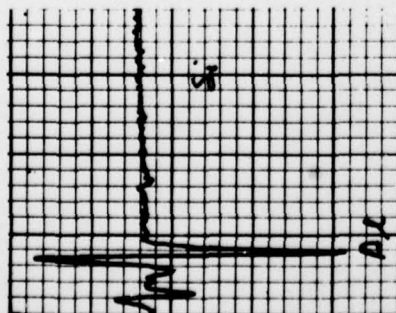
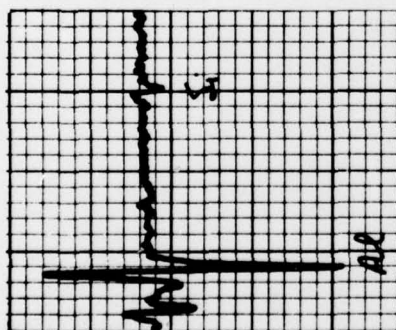
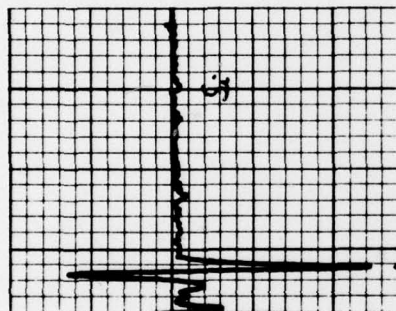
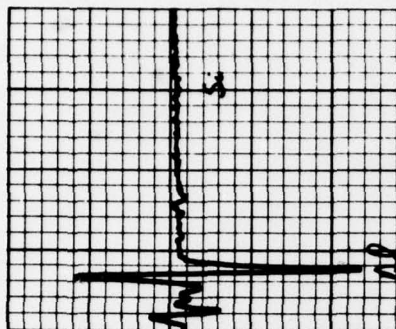
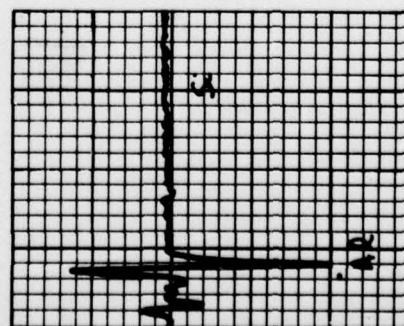
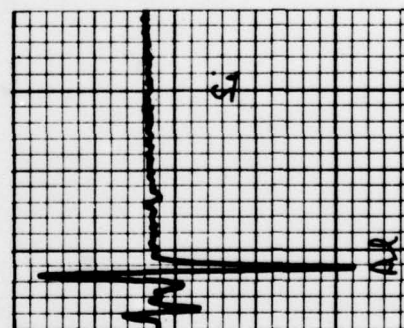
SPECTROGRAMS OF 7075 ALCLAD ALUMINUM AFTER AMLGUARD APPLICATION AND SOLVENT WIPE REMOVAL TREATMENT

2. AS REF B INDICATED, ADDITIONAL SOLVENTS/THINNERS WERE TESTED FOR REMOVABILITY OF SUBJ MATERIAL. THE FOLLOWING WERE FOUND TO THOROUGHLY REMOVE THE SUBJ MATERIAL FROM THE TEST SURFACES: MIL-T-19544 THINNER, MIL-T-81772 THINNER, ACETONE, ISOPROPYL ALCOHOL, MINERAL SPIRITS, AND METHYL ETHYL KETONE. THE METHYL ETHYL KETONE WAS FOUND TO BE SATISFACTORY UPON FURTHER CHECK.
